CASE STUDY: WAIRAU 33kV CABLE JOINT REPLACEMENT

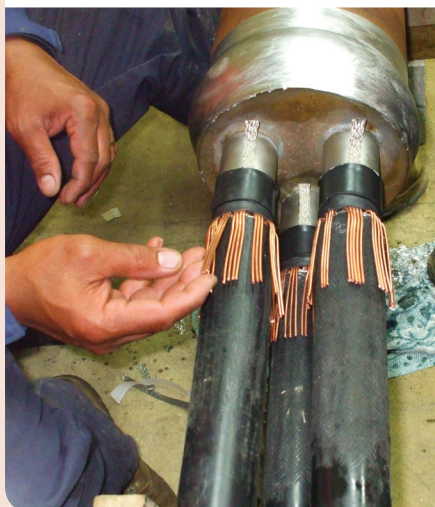
- 400 litres of cable oil used
- 80 metres of single core 400mm² XLPE 33kV cable replaced
- 1 XLPE oil stop joint replaced

With no standard materials available, Northpower engineers sourced and imported some parts and modified or custom-built others.

The damaged joint was isolated, replaced and commissioned successfully and the cable returned to service with minimal disruption to bus services.
